## DESIGN OF GNSS NETWORKS FOR MONITORING EARTH DAMS DEFORMATIONS

**ABSTRACT.** The paper presents a series of results regarding the application of GNSS technology for measuring displacements to earth dams. An appropriate horizontal and vertical deformation-tracking network must be established for the rapid monitoring of earthmoving movements. Data obtained from the monitoring network can be used in the earth dam stability analysis program. Periodic tracking of earth dams using GNSS technology provides high accuracy of spatial distortions. The results of the paper show the application of GNSS technology to monitor the deformations of the Podisu earth dam located on the Sheep Valley River in Iasi County. In the first stage of research (2019 and 2020), the local geodetic tracking network was created. To monitor the dam, four control landmarks were placed on the crest of dam and seven landmarks on the downstream slope. In the second stage of the research (year 2021) the measurements of the displacements at the earth dam were performed. The GNSS monitoring method has the advantage of positioning the target quickly, statically, and with high accuracy. The measurements used fixed statio

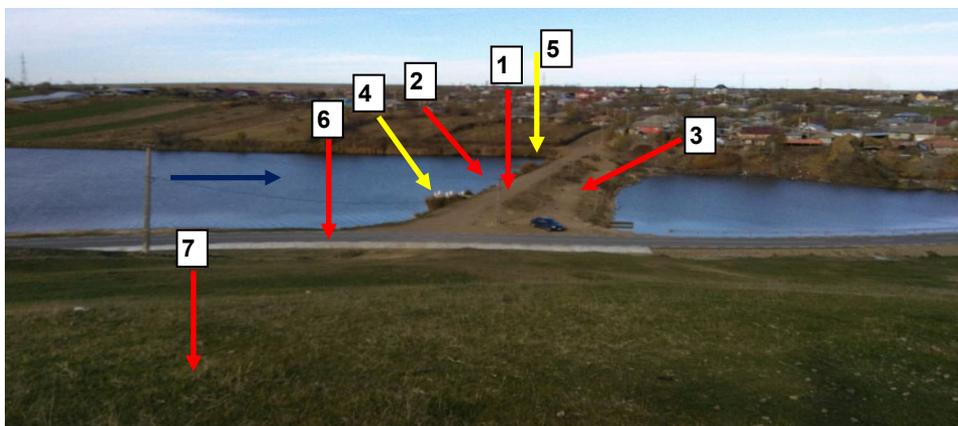
**Figure 1 - General view of the Podișu dam: 1 – crest of a dam; 2 - upstream slope; 3 - downstream slope; 4 - bottom water outlet C1; 5 - funnel overflow C2; 6 - road; 7 - the right slope (source: author)**

The object of study is the Podișu earth dam, which is classified as a category C dam (Fig. 1). The dam is located on the Sheep Valley River, in the area of the Baltati

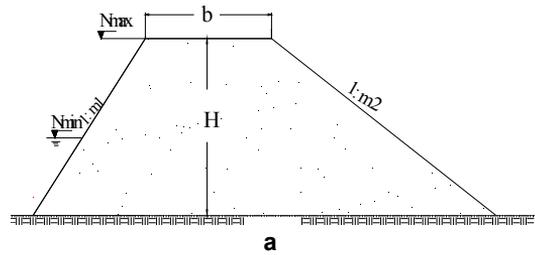
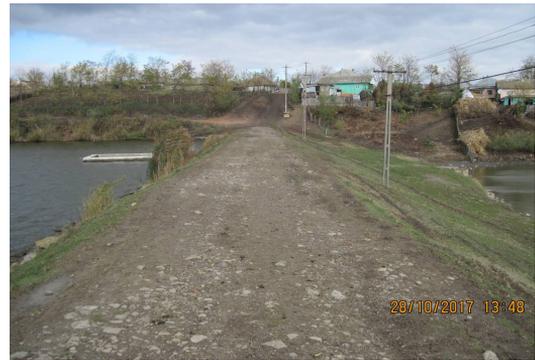
Figure 3 - Podisu earth dam: a - cross section initially executed (Sbiera, 2006); b - general view of the dam, year 2021 (source author)

The Podișu dam is homogeneous in structure and was constructed in 1962, from land taken from the location area. The cross section of the dam has a trapezoidal shape and the geometric parameters are as follows (Sbiera, 2006) (Fig. 3):

- maximum height 3.90 m;
- length of dam crest 104.0 m and width 4.50 m;
- the slope of the upstream shell 1: 1.0 and the downstream shell 1: 2.0.

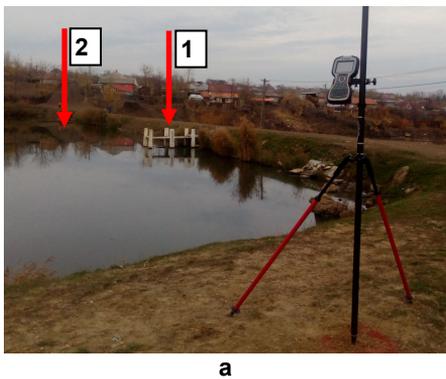
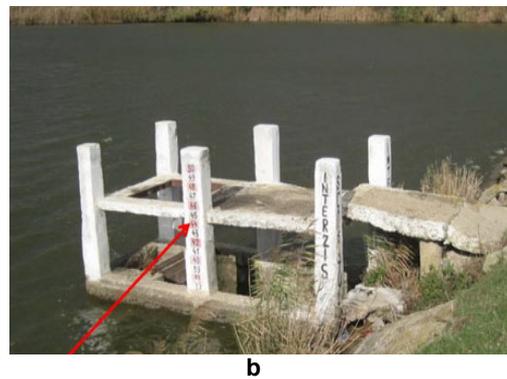
Figure 4 – Flow evacuators of the Podisu dam: a - general view upstream of the dam with the positioning of the evacuators; 1 - C1, 2- C2; b - detail regarding the C1 evacuator and the position of the water meter (source: author).

The evacuators are located in the body of the dam on the upstream slope as follows (Fig. 4.a): C1 on the right and C2 on the left.

The C1 evacuator structure is a manoeuvring tower provided with a spillway on three sides (Fig. 4b). The front spillway has a ridge at a lower level, and over it, are mounted cofferdams to regulate the water level in the lake and the discharged flow. The bottom outlet pipe has a mixed cross section (rectangle semicircle) with dimensions of 1.00 x 1.60 m (Sbiera, 2006).

length of 19.0 m. The bottom outlet gallery has a rectangular section measuring 2.00 x 2.00 m (Sbiera, 2006). The two exhaust constructions are made of reinforced concrete. The Podisu dam does not have control parts installed for measuring the movements on the crest and face slopes, a situation determined by its category of importance. Only the water level in the lake is measured directly, at the water meter located on the wall of the C1 evacuator (Fig. 4.b).

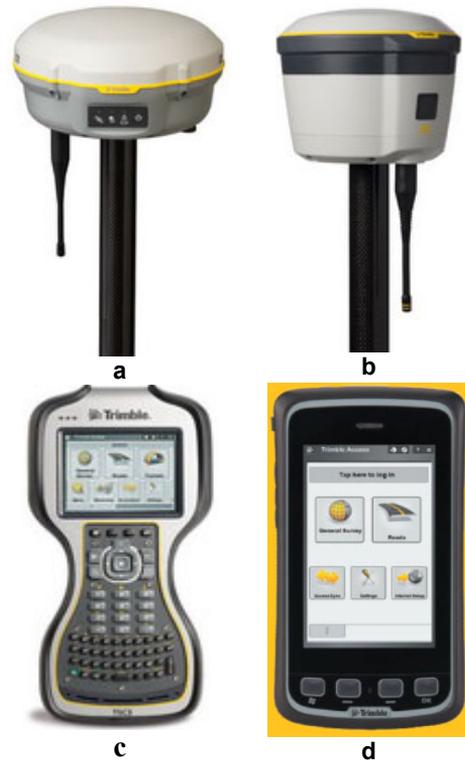
**Figure 5 - GNSS equipment used for measurements: a - Trimble R8S receiver; b - Trimble R2 receiver; c - Trimble TSC3 control unit; d - Trimble Slate control unit**

- choice of GNSS equipment; it consists of Trimble R8S, Trimble R2 receivers and Trimble TSC3 and Trimble Slate control units (*Fig. 5*);

For the Podisu dam, four Trimble GNSS receivers, three R8S receivers and one R2 receiver were used for the measurements. The control units used were a Trimble TSC3 and a Trimble Slate.

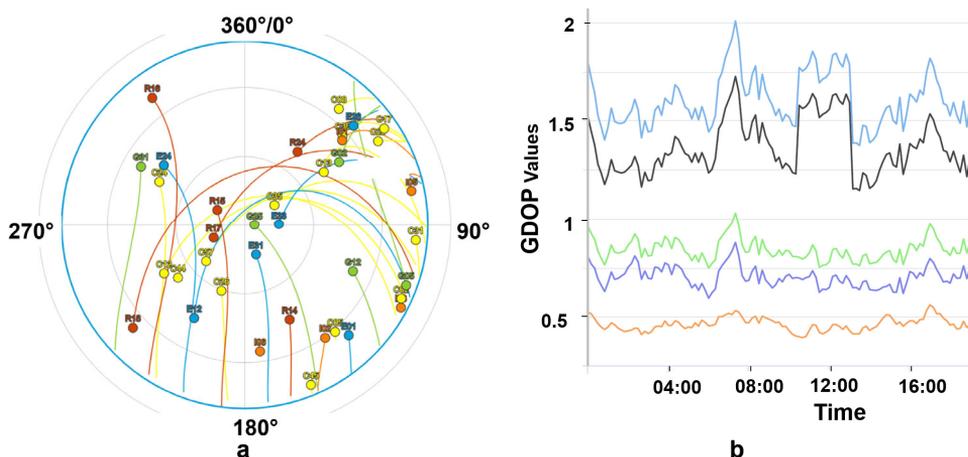
**Figure 6 - Observation planning: a – satellite trajectories: ● - GPS; ● - GLONASS; ● - GALILEO; ● - BEIDOU; ● - QZSS; ● - IRNSS satellite constellations; b – the graph of GDOP value: cyan line – geometric; black line – time; green line – positioning; blue line – vertical; orange line - horizontal (source: Trimble GNSS Planning Online).**

- planning the observations in time according to the changes in the geometry of the dam; the observations were made based on the data provided on the Trimble GNSS Planning Online website (number and type of satellites present in the research area, possible GDOP values in measurements, etc.);

- *Fig. 6* shows the planning of observations for the first cycle of measurements conducted in November 2019.

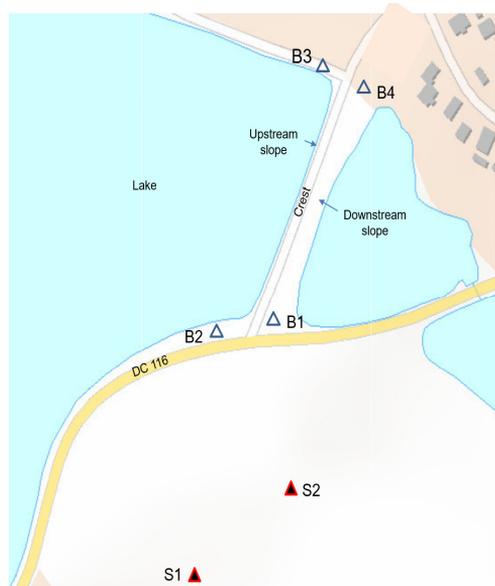
**Figure 7 - Geodetic monitoring network designed for the Podisu dam**

The designed local geodetic tracking network consists of the following components (Fig. 7):

- two reference points (S1, S2) located on the right slope in the vicinity of the dam;
- four station points (B1, B2, B3, B4) located near the dam, in stable areas.

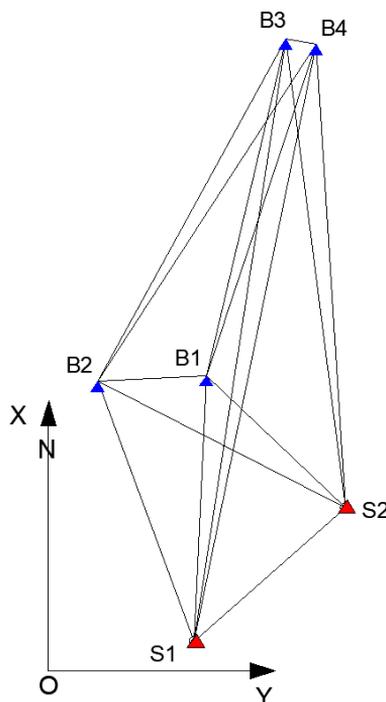
**Figure 8 - GNSS Representation vectors in the monitoring network: red points – fixed reference points; blue points – new points in the local network**

Straight segments that connect the stationary points according to the projected vectors represent the scheme of the observation sessions (Fig. 8). GNSS vector processing was performed automatically in the Trimble Business Centre program. In 2019 (cycle 0) there were 60 GNSS vectors and in 2021 (cycle 1) there were 36 GNSS vectors.

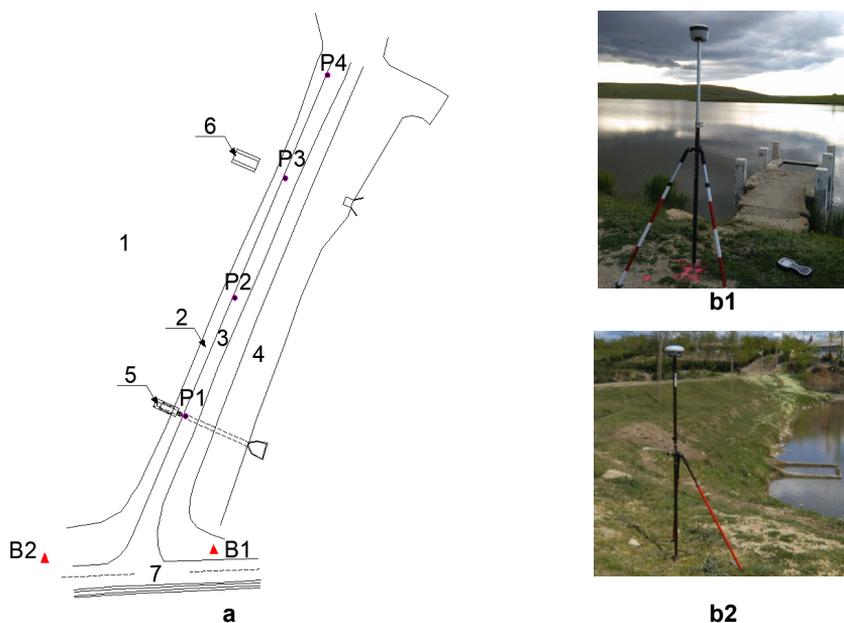
Figure 9 - Organisation and performance of measurements: a - dam representation scheme, 1 – water storage, 2 – upstream slope, 3 – dam crest, 4 – downstream slope, 5 – flow evacuation construction C1, 6 - flow evacuation construction C2, 7 – road; B1 and B2 – station points; P1, P2, P3, P4 – control points located on the dam crest; b – positioning the receivers: b1 – in control point P1, b2 – in station point B1.

In order to monitor the movements at the Podisu dam, four control points were monitored on the crest (P1-P4) (Fig. 9). At these points, rapid static GNSS observation sessions were conducted, with fixed stations at points B1 and B2, previously determined within the local geodetic tracking network.

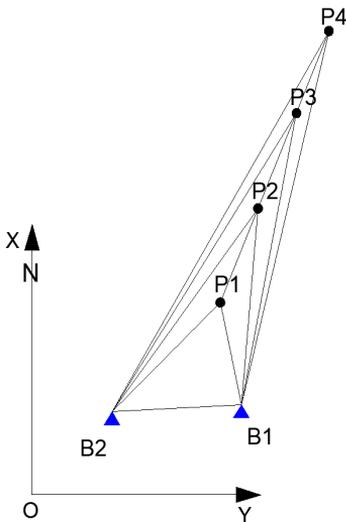
Figure 10 - GNSS vectors following the landmarks on the dam crest: B1, B2 - station points; P1, P2, P3, P4 - control points

To determine the control points (P1-P4), three series of measurements were performed, resulting in 18 GNSS vectors (Fig. 10). The spatial coordinates of the control points fixed to the crest of a dam, resulting from the two cycles of measurements performed in May and July 2021 were centralised in Table 3.

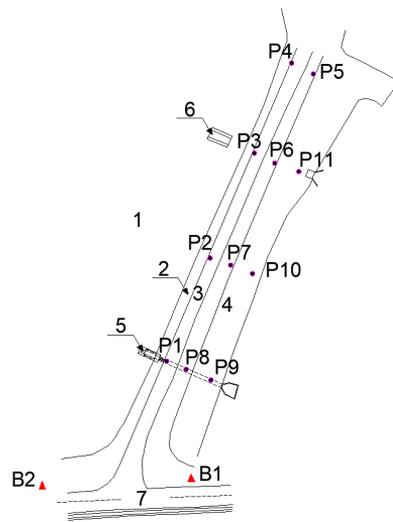
Figure 11 – Plan with control points on the dam crest and downstream slope: 1 – water storage; 2 – upstream slope; 3 – dam crest; 4 – downstream slope; 5, 6 – flow evacuation (C1, C2); 7 – road; B1, B2 – station points; P1...P4 – control points on the dam crest; P5...P11 – control points on the downstream slope.

In July 2021, a set of measurements was taken and the coordinates of the 11 control points fixed on the dam crest (P1 ... P4) and the downstream slope (P5 ... P11) were determined in relation to the station points B1 and B2 (Fig. 11).

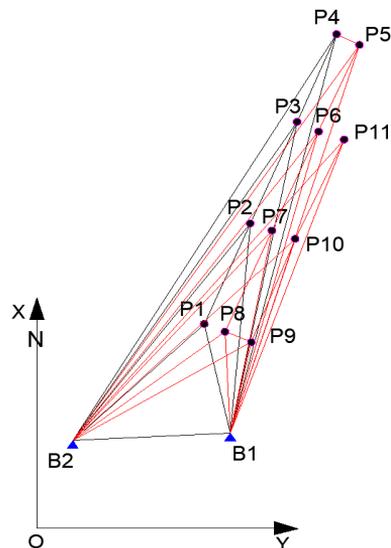
Figure 12 – The complete dam tracking network and GNSS vectors: B1, B2 – station points, P1...P4 – control points on the crest; P5, P11 – control points on the downstream face slope

Four Trimble GNSS receivers were used for field data collection and 10 measurement sessions were performed. The duration of a measurement session was about 11 minutes. During the processing of the measurements through the Trimble Business Centre program, 60 GNSS vectors were obtained (Fig. 12).
